3809 REPORT OF INSPECTION

S/047/050

Serial no. of notice: UTU 66357 (Bluebell Oil Co project area) Is the operation active? No (expired)

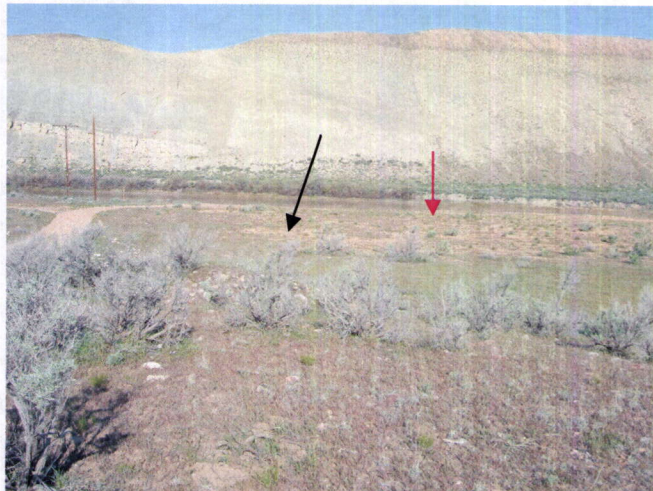
< figure 1, view to west (from near SE corner of project area); southern part of project area is against road at left; western part of project area is over edge (pointed to by red arrow; this side of water body, the Green River), but which is not into the flood plain; southeastern part of project area was not subjected to the last placer activity on location (referred to a naturally revegetating [black arrow points at it] area below; has not been seeded by the operator, has some desirable native volunteer vegetation emerging, but at a lesser density as nearby undisturbed land). Compare with frame 1 of 5/04 inspection

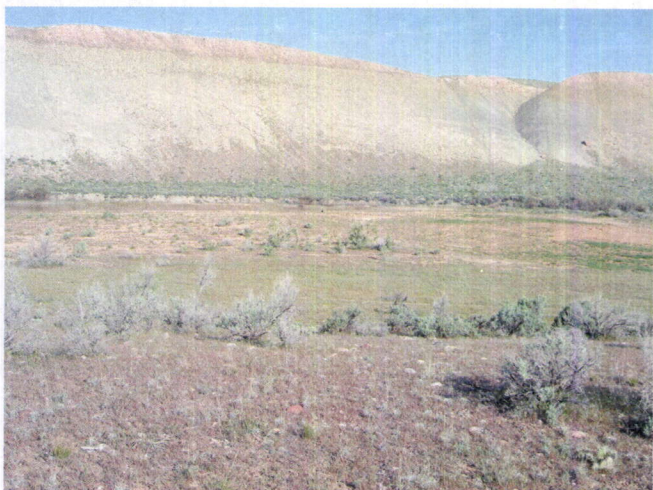
< figure 2, view to west-northwest (pan to right of image 1), area of reshaping in 9/2004 is from right-center to middle part of image (naturally revegetating area is to left, of greener patch at far-right – this patch is composed mostly of cheatgrass which is emerging)
Compare with frame 2 of 5/04 inspection

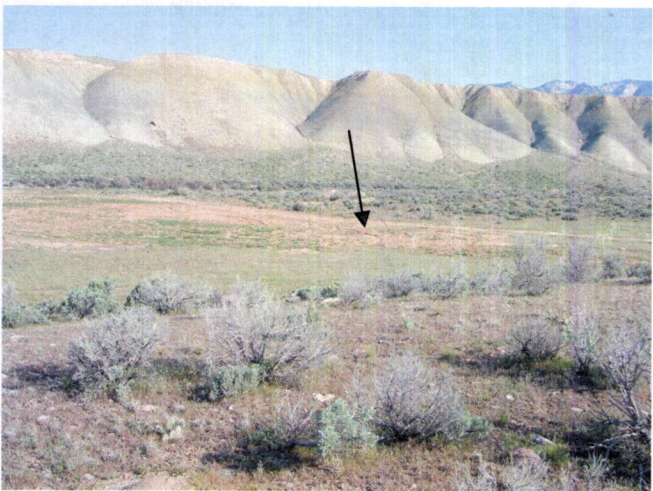
< figure 3, view to northwest (pan to right of image 2), northeast corner of project area is at far right-center, area where ATV's have traveled is at right-center (black arrow points at it)
Compare with frame 2 of 5/04 inspection.
